TIRE INFORMATION SERVICE BULLETIN

SIDEWALL INDENTATIONS IN RADIAL TIRES

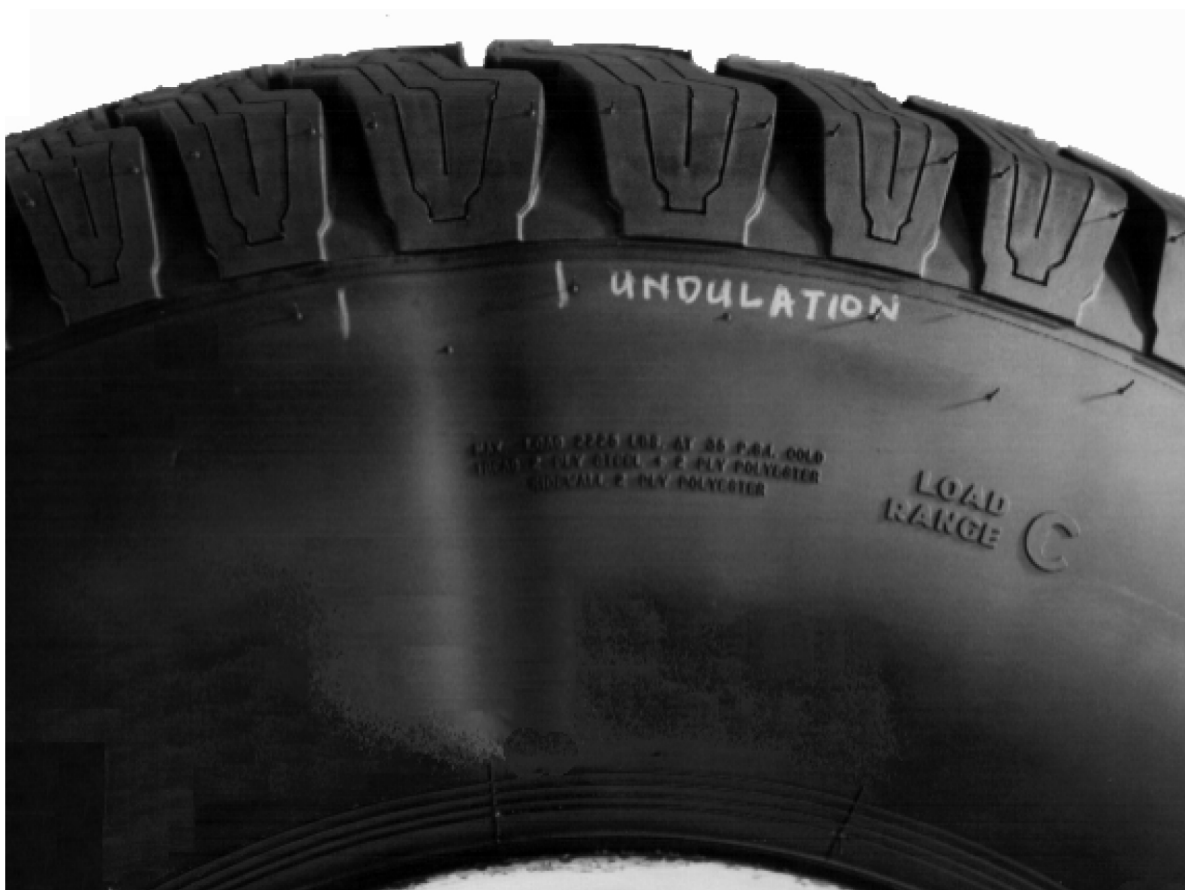
The condition, sometimes referred to as sidewall undulations, is a common characteristic of radial tire construction. These indentations are more noticeable in tire sizes with higher aspect ratios and/or higher inflation pressures.

In a radial tire the body ply cords run straight across the tire from bead to bead. The joining of the ply material creates a narrow overlap of ply cords in the radial direction at each junction. These overlapped ply cords slightly restrict the natural expansion of the sidewall when inflated. This results in an indentation. Since the belt plies reinforce the tread, only the sidewalls are indented.

Sidewall indentations are a cosmetic characteristic and will not affect the performance of the tire. If bulges, rather than indentations, appear on the sidewall or if there is any question concerning the sidewall appearance, the tire should be examined by a tire service professional.
