AIRCRAFT TIRE SERVICE BULLETIN

FOREIGN OBJECT DEBRIS (FOD)

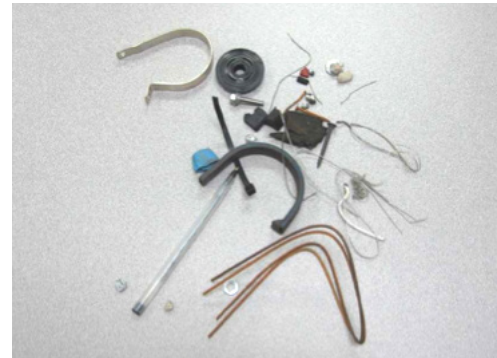
FIGURE 1: Typical Operating Area FOD

- Appealing to airport authorities for preventative programs
- Educating all involved airport personnel to heighten awareness
- Encouraging and enforcing regular Aircraft Operating Area inspections to remove debris

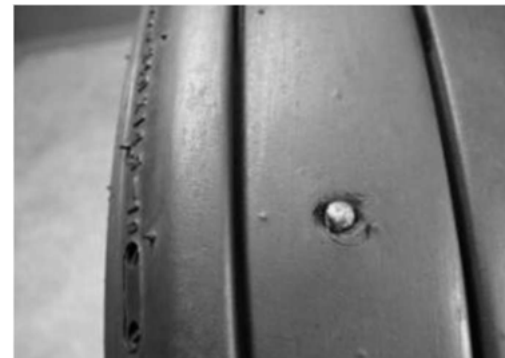
FIGURE 2: FOD Tire Damage Example

If FOD damage to a tire is discovered, applicable removal criteria should be applied to determine if the tire can remain in service. These criteria can be found in documents such as the Aircraft Maintenance Manual (AMM) and tire manufacturers’ care and service manuals.
