TIRE INFORMATION SERVICE BULLETIN

SIDEWALL INDENTATIONS IN RADIAL TIRES

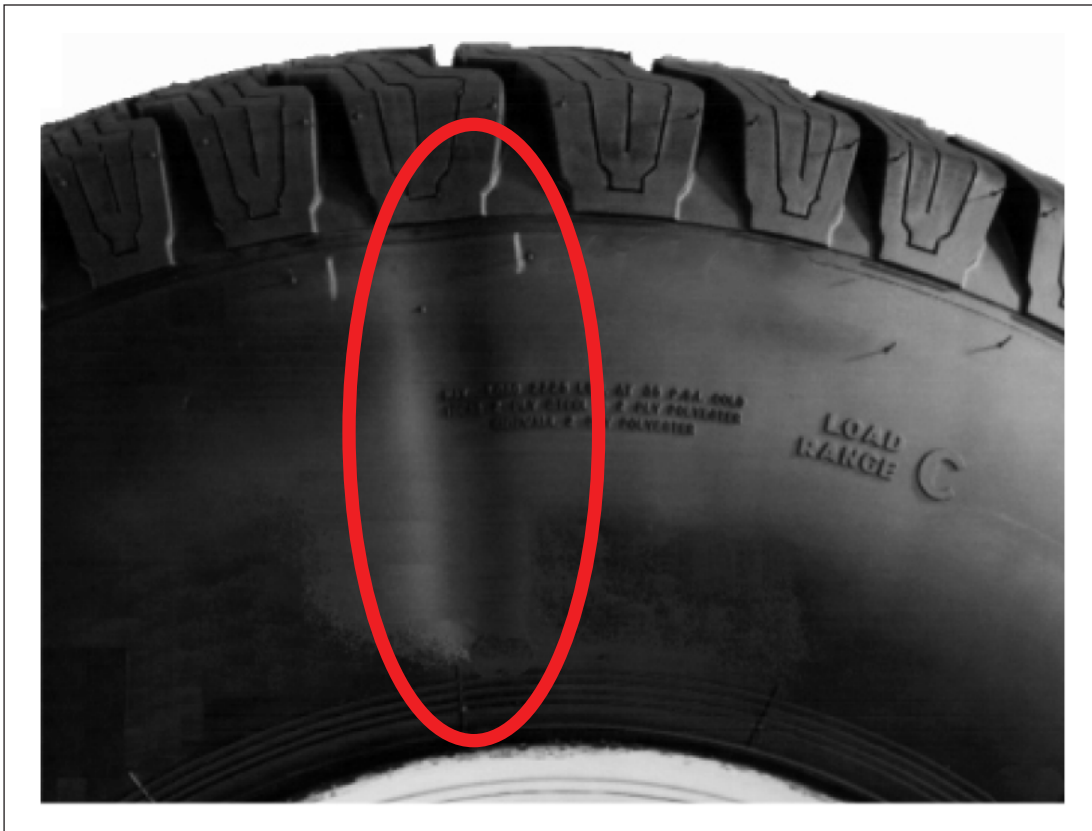
The condition, sometimes referred to as sidewall undulations, is a common characteristic of radial tire construction. These indentations are more noticeable in tire sizes with higher aspect ratios and/or higher inflation pressures.

In a radial tire the body ply cords run straight across the tire from bead to bead. The joining of the ply material creates a narrow overlap of ply cords in the radial direction at each junction. These overlapped ply cords slightly restrict the natural expansion of the sidewall when inflated. This results in an indentation. Since the belt plies reinforce the tread, only the sidewalls are indented.

FIGURE 1: Example of a sidewall indentation

Sidewall indentations are a cosmetic characteristic and will not affect the performance of the tire. If bulges, rather than indentations, appear on the sidewall, or if there is any question concerning the sidewall appearance, the tire should be examined by a tire service professional.
