TIRE INFORMATION SERVICE BULLETIN

SIDEWALL INDENTATIONS IN RADIAL TIRES

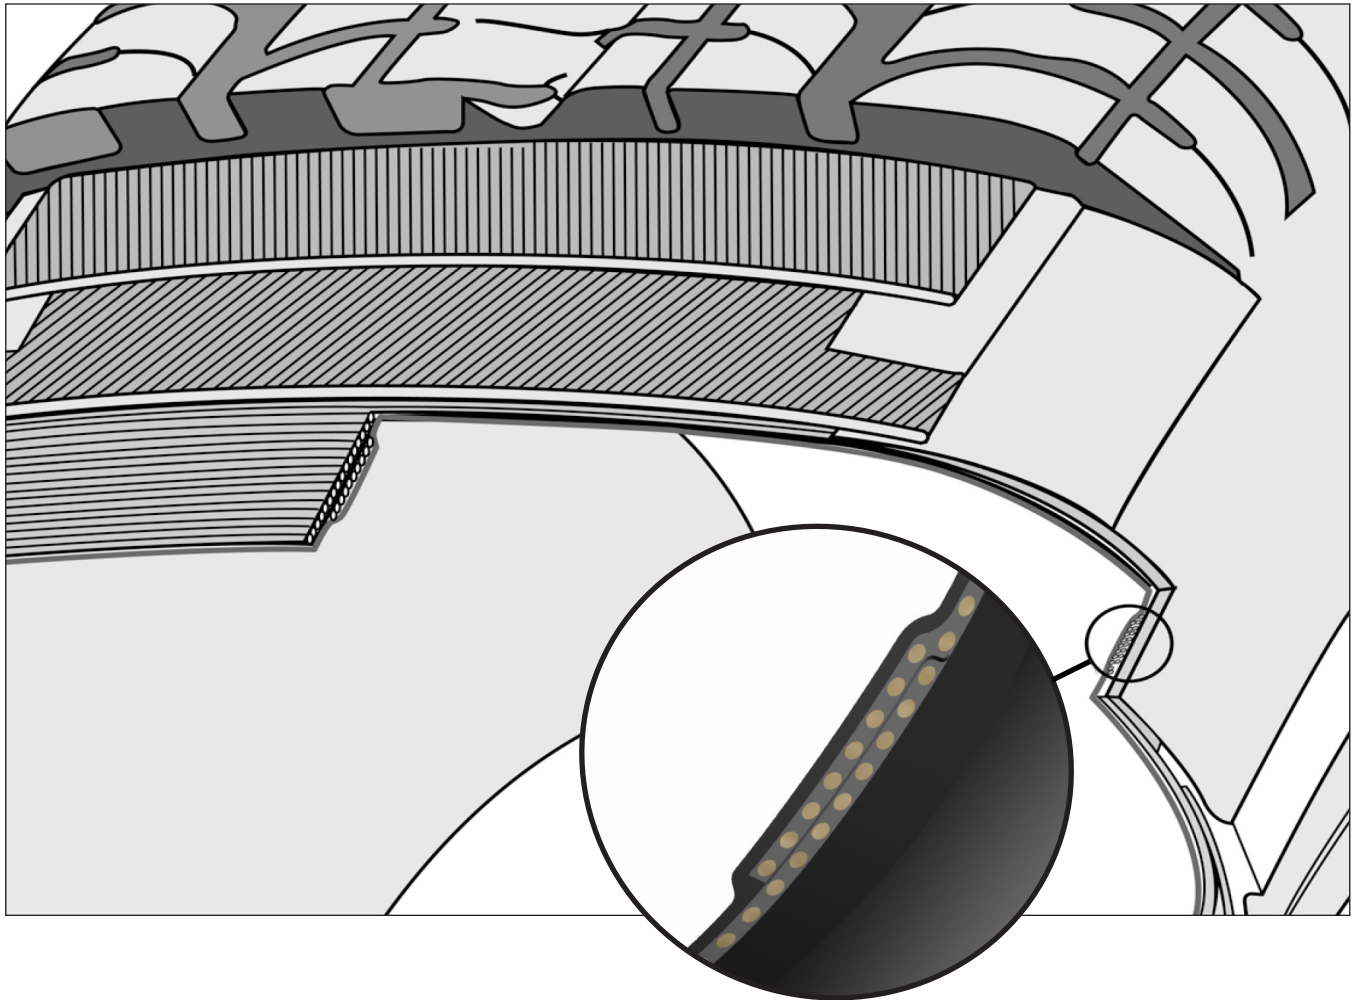
FIGURE 1: Example of a sidewall indentation

The condition, sometimes referred to as sidewall undulations, is a common characteristic of radial tire construction. These indentations are more noticeable in tire sizes with higher aspect ratios and/or higher inflation pressures.

In a radial tire the body ply cords run straight across the tire from bead to bead. The joining of the ply material creates a narrow overlap of ply cords in the radial direction at each junction. These overlapped ply cords slightly restrict the natural expansion of the sidewall when inflated. This results in an indentation. Since the belt plies reinforce the tread, only the sidewalls are indented.

Sidewall indentations are a cosmetic characteristic and will not affect the performance of the tire. If bulges, rather than indentations, appear on the sidewall, or if there is any question concerning the sidewall appearance, the tire should be examined by a tire service professional.
